BANK STABILITY ANALYSIS FOR THE UPPER MISSOURI RIVER

STEPHEN E DARBY and COLIN R THORNE

FINAL REPORT TO

**UNIVERSITY OF NOTTINGHAM
UK**

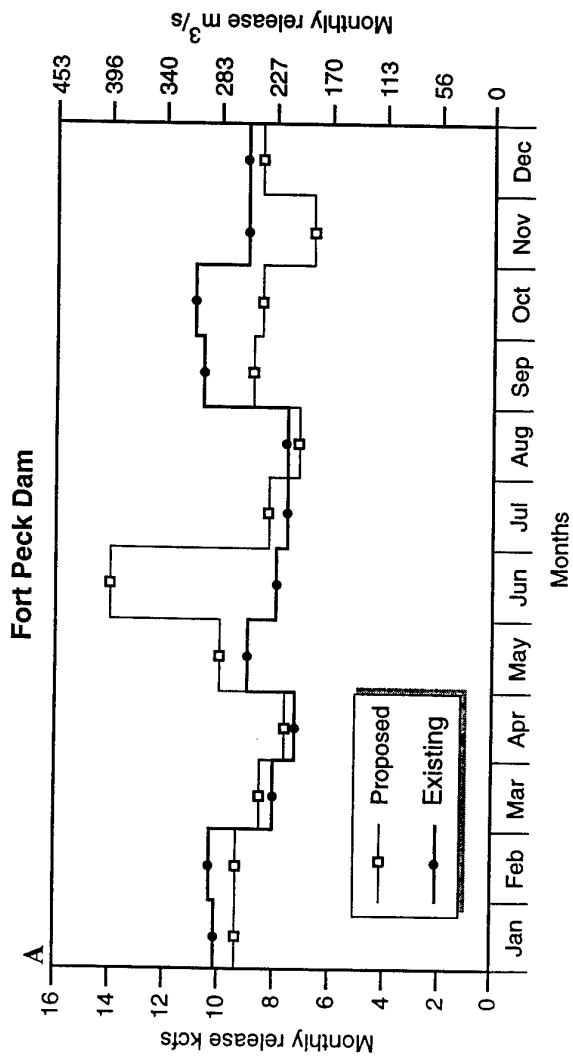
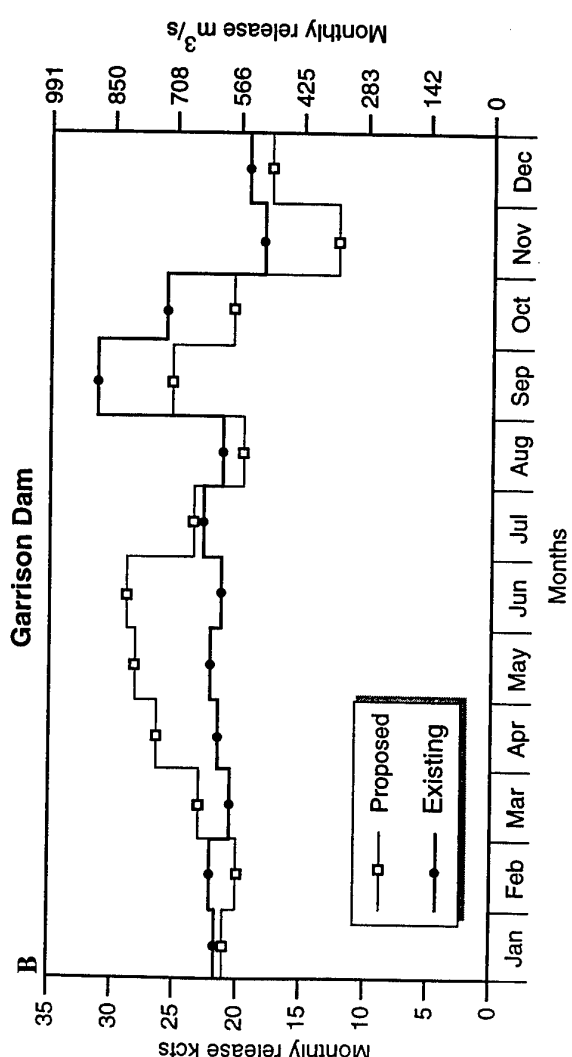
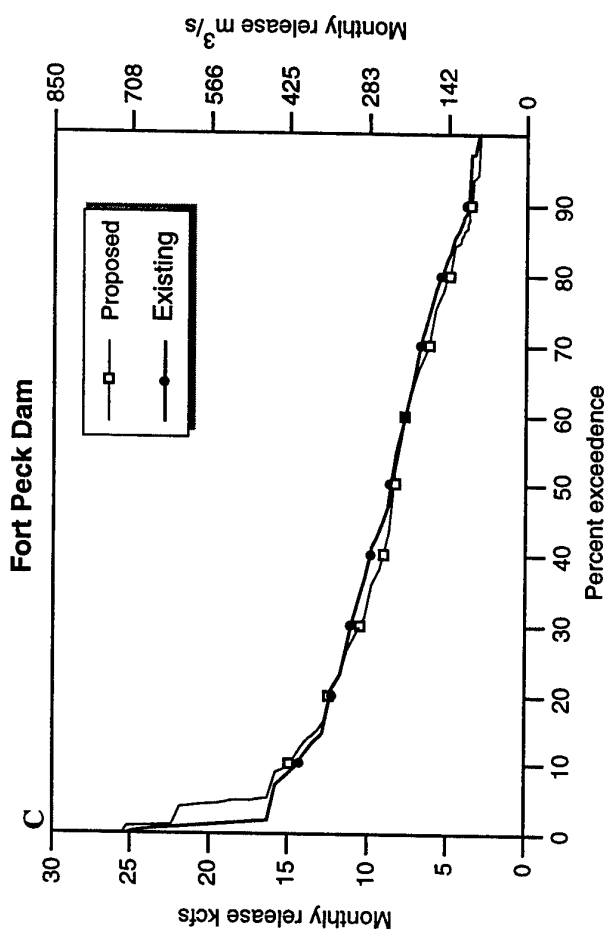
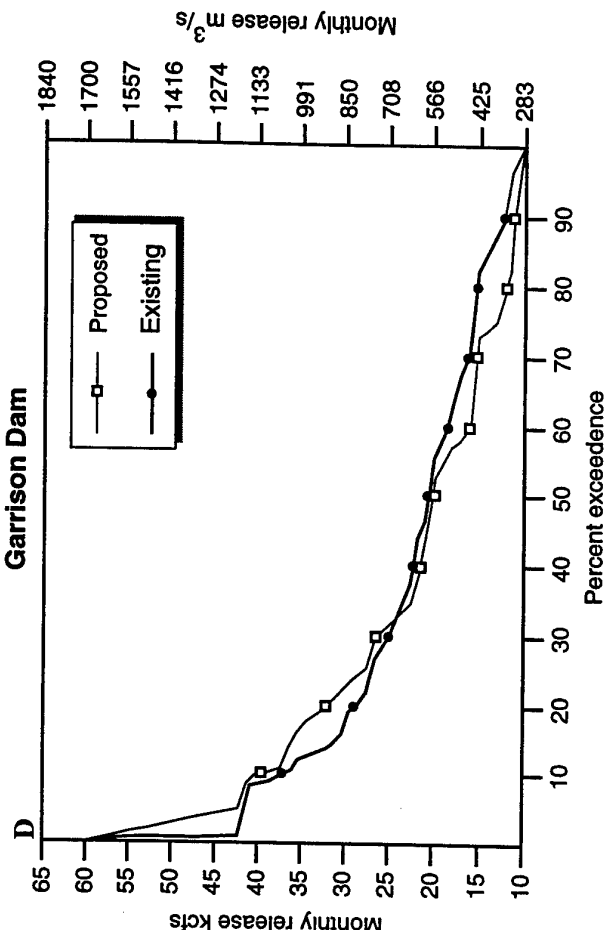
FIGURE 2

Figure 2. Comparison of proposed and existing flow regimes: (A) Proposed and existing annual hydrographs, Fort Peck dam; (B) Proposed and existing annual hydrographs, Garrison dam; (C) Proposed and existing flow duration curves, Fort Peck dam; (D) Proposed and existing flow duration curves, Garrison dam. Note that proposed and existing hydrographs are planned discharge releases. In fact, actual releases (existing flow regime) during the period of record have been modified according to catchment hydrological conditions, and have diverged markedly during periods when runoff rates were significantly above or below average. In contrast, the flow duration curve for the existing flow regime is based on the actual record of flows.

Changes in the operation of Fort Peck and Garrison Dams on the Upper Missouri River in Montana and North Dakota (Figure 1) have been proposed as a means to protect fisheries and wildlife interests, while continuing to fulfill essential flood-water storage and hydropower functions. The action agency responsible for river management and engineering (United States Army Corps of Engineers (COE)) is interested in predicting whether or not these operational changes might cause discernible impacts on bank erosion processes, bank stability with respect to mass failure, and rates of bankline migration. Annual hydrographs and flow duration curves for the existing and proposed operating regimes of Fort Peck and Garrison dams are shown in Figure 2. The proposed flow regime would have the effect of increasing discharge releases during spring and summer months, but decreasing discharge at other times (Figures 2a and 2b). Peak discharge will be increased from approximately $310 \text{ m}^3/\text{s}$ to $400 \text{ m}^3/\text{s}$ in the Fort Peck dam reach, but will be decreased from approximately $890 \text{ m}^3/\text{s}$ to $840 \text{ m}^3/\text{s}$ in the Garrison dam reach. In both reaches, existing baseflows will be reduced under the proposed operating schemes and the overall impact of proposed changes in dam operation will be to increase flow duration for relatively large magnitude flows and reduce flow duration for lower magnitude flows (Figures 2c and 2d).

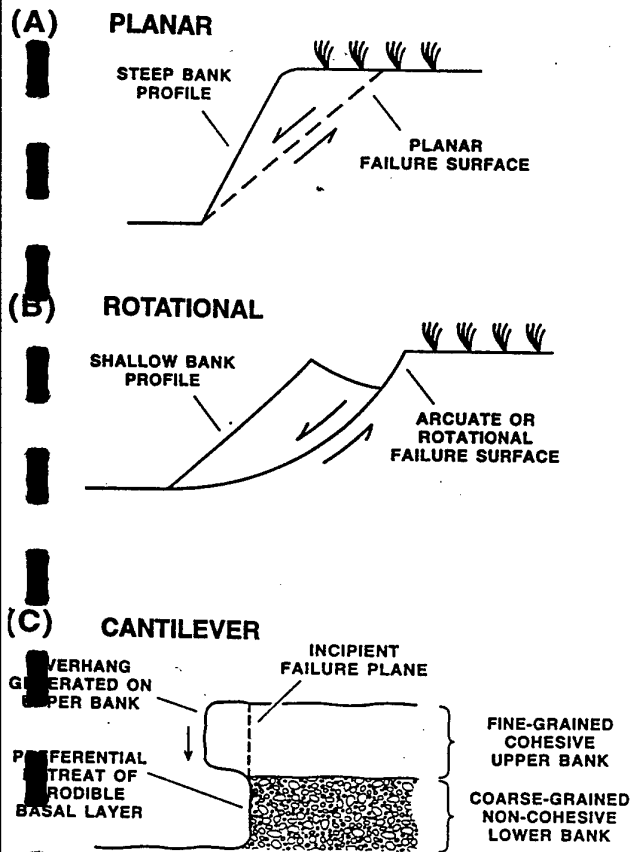
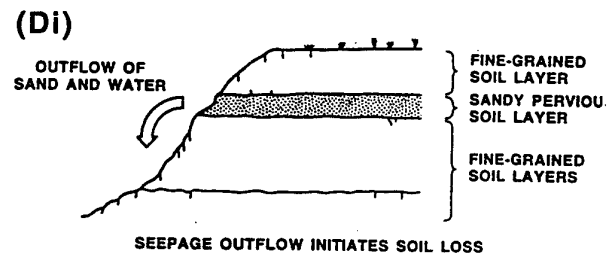
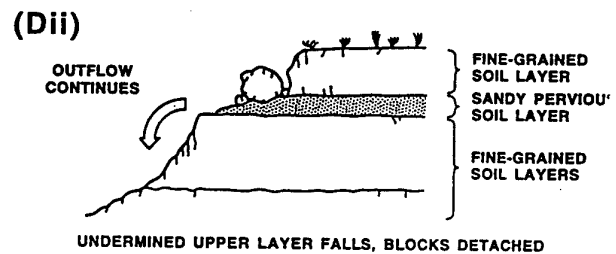
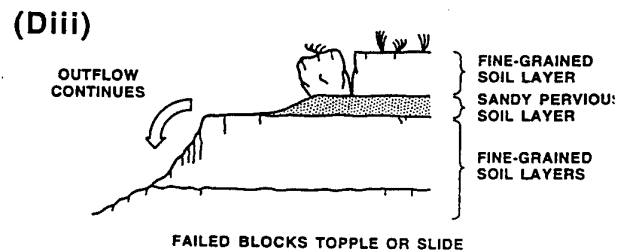
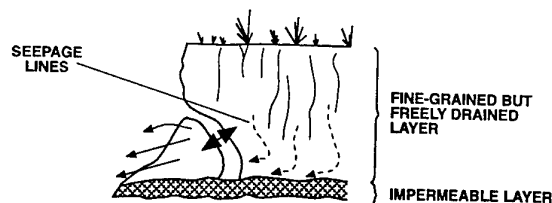
FIGURE 3

Figure 3. Bank failure mechanisms observed during field reconnaissance: (A) Planar failure; (B) Rotational failure; (C) Cantilever failure; (D) Sequence of events in Piping/Sapping type failures; (E) Pop-out failure

BANK EROSION BY PIPING/SAPPING WITH SUBSEQUENT COLLAPSE

(E) POP OUT

A stream reconnaissance was made by boat in accordance with guidelines documented by Thorne (1993). Approximately 160 miles of bank (62% of the study reaches) were classified according to stratigraphy, profile, failure mechanism, and overall stability. Bank-failure mechanisms were classified as being of the planar, rotational, cantilever, piping/sapping, or

pop-out type (Figure 3). Failure mechanisms were recorded on 1:24000 scale aerial photographs as the boat progressed downstream, and later used to estimate the locations and percentage lengths of stable and unstable banks, and the proportion of unstable bankline in each failure category. Notes were made regarding the geomorphic context of bank retreat at each location and, particularly, how failure categories related to position at channel bends. Photographs were taken at a total of 126 sites along the two study reaches. Examples of these photographs are shown in Plate 1.

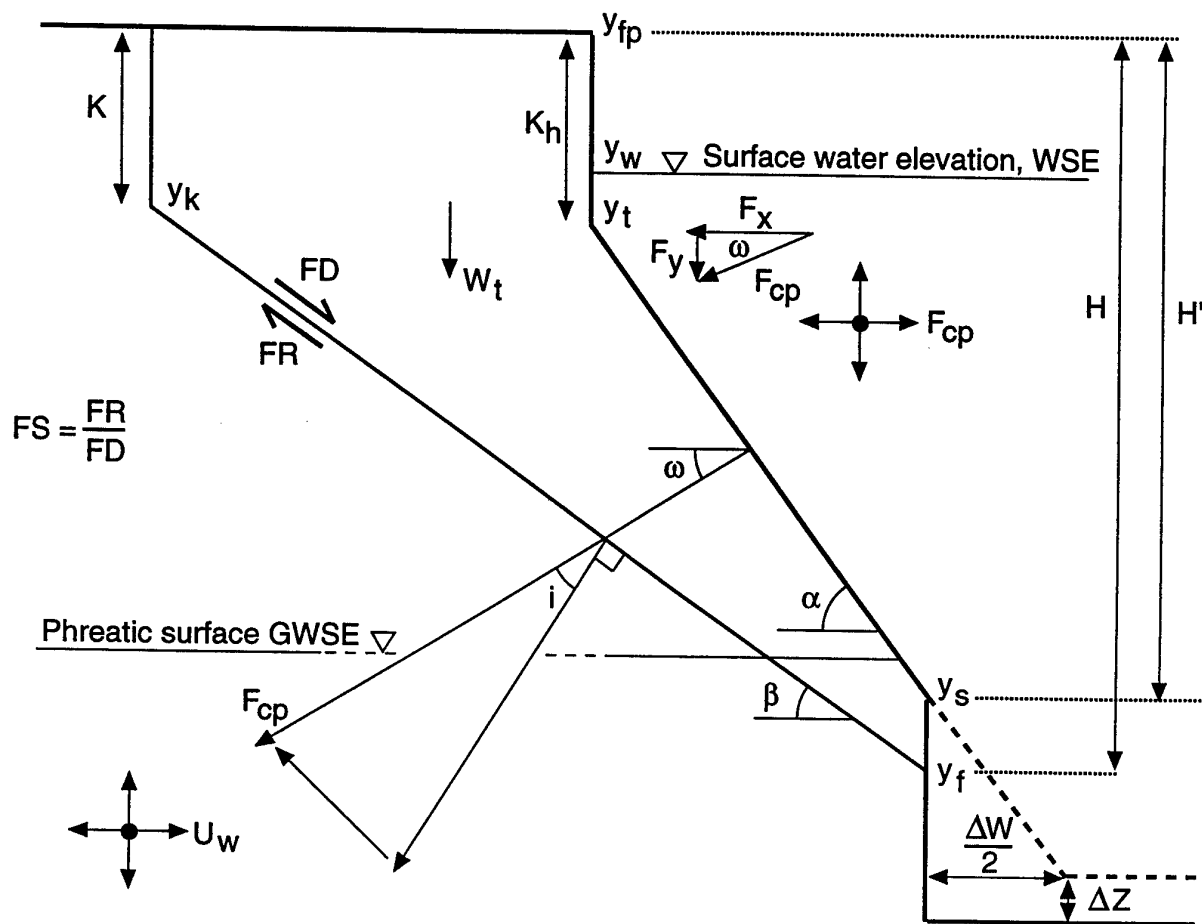
FIGURE 4

Figure 4. Definition diagram for the Darby-Thorne bank stability analysis (from Darby and Thorne, 1996). Symbols: K = tension crack depth, K_b = relic tension crack depth, i = uneroded bank angle, β = failure plane angle, U_w = pore pressure, F_{cp} = hydrostatic confining pressure, ω = angle between uneroded bank profile and resultant of hydrostatic confining pressure, α = angle between resultant of hydrostatic confining pressure and normal to failure plane, GWSE = ground water surface elevation, WSE = y_w = surface water elevation, W_t = weight of failure block, FD = driving force, FR = resisting force, y_b = floodplain elevation, y_t = elevation of base of relic tension crack, y_s = elevation of base of uneroded bank slope, y_f = elevation of base of failure plane, y_k = elevation of base of tension crack, ΔZ = amount of near-bank bed scour, $\Delta W/2$ = amount of fluvial bank erosion

To apply the analysis, bank height, tension crack depth, relic tension crack depth and angle of the uneroded bank slope are required to describe the geometry of the bank profile (Figure 4). Cohesion, friction angle and unit-weight values are used to characterize geotechnical soil properties. Ground water and surface water elevations are used to simulate the effects of bank hydrology on stability. Input data parameters corresponding to bank

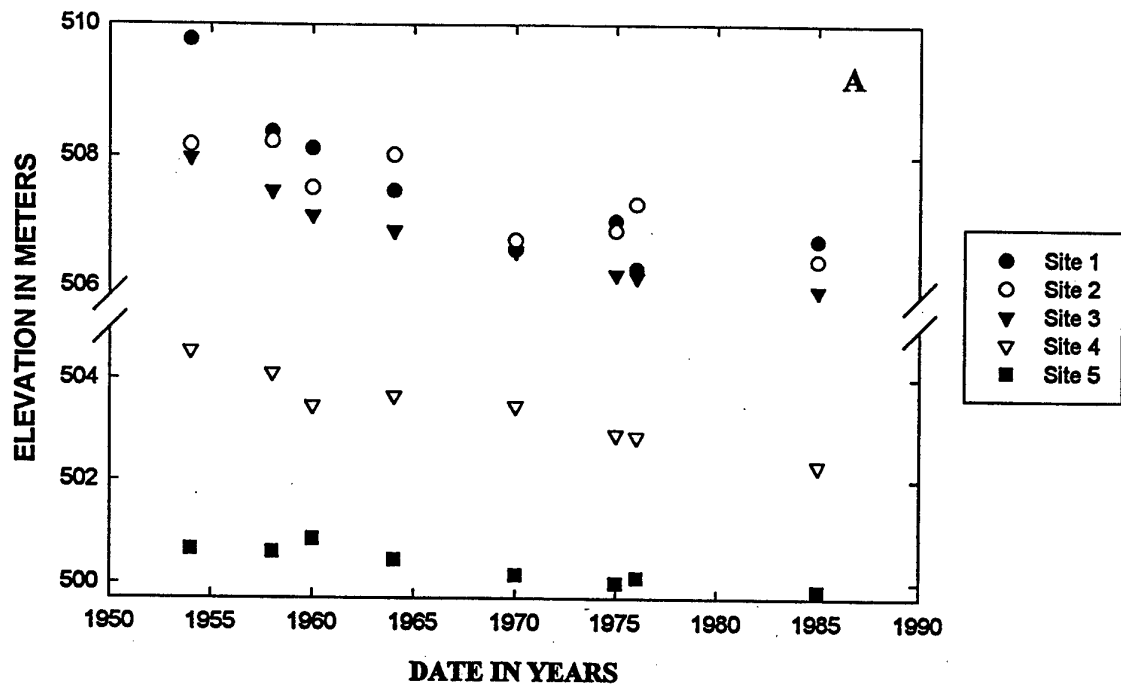
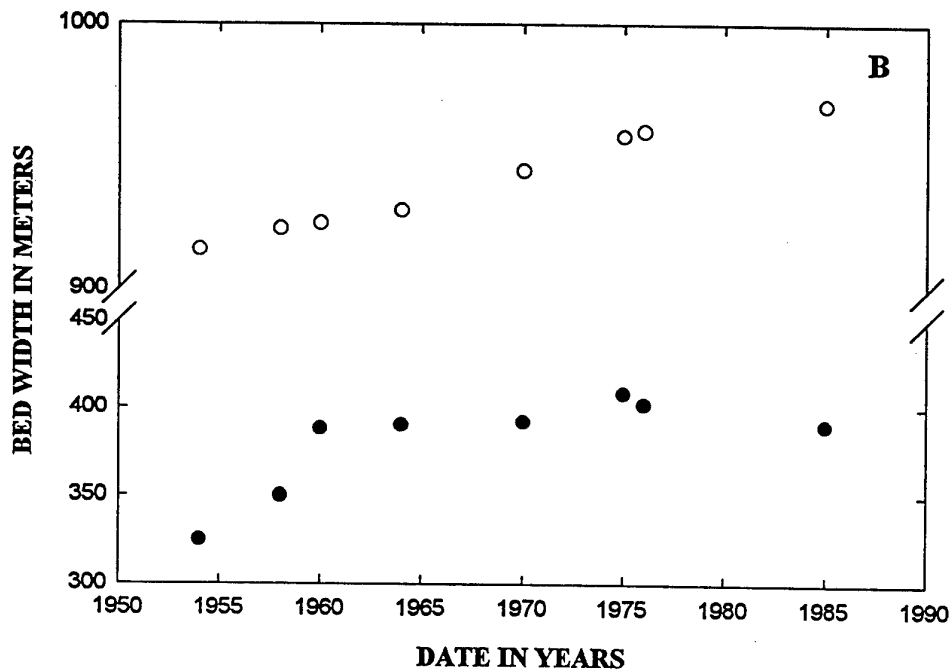
FIGURE 7

Exponential and logarithmic regression curves were fitted to the data so obtained. Examples are shown in Figure 7. The regression relationship that most closely fitted the survey data (highest r^2 value) was selected for use in extrapolating future channel response to the regulated flow regime. Estimates of cumulative amounts of near-bank bed degradation (ΔZ) and bank-toe erosion ($\Delta W/2$) compared to estimated channel-bed conditions at the present time (1995) projected 1 (1996), 5 (2000), 10 (2005), 20 (2015) and 50 (2045) years into the future (Table 5) were obtained by extrapolation of the empirical regression curves listed in Table 4. It is stressed that the 1995 reference values of mean bed elevation and bed width are themselves extrapolated estimates, since the dates of the last surveys used to construct the regression curves are 1978 and 1985, for the Fort Peck and Garrison dam reaches, respectively.

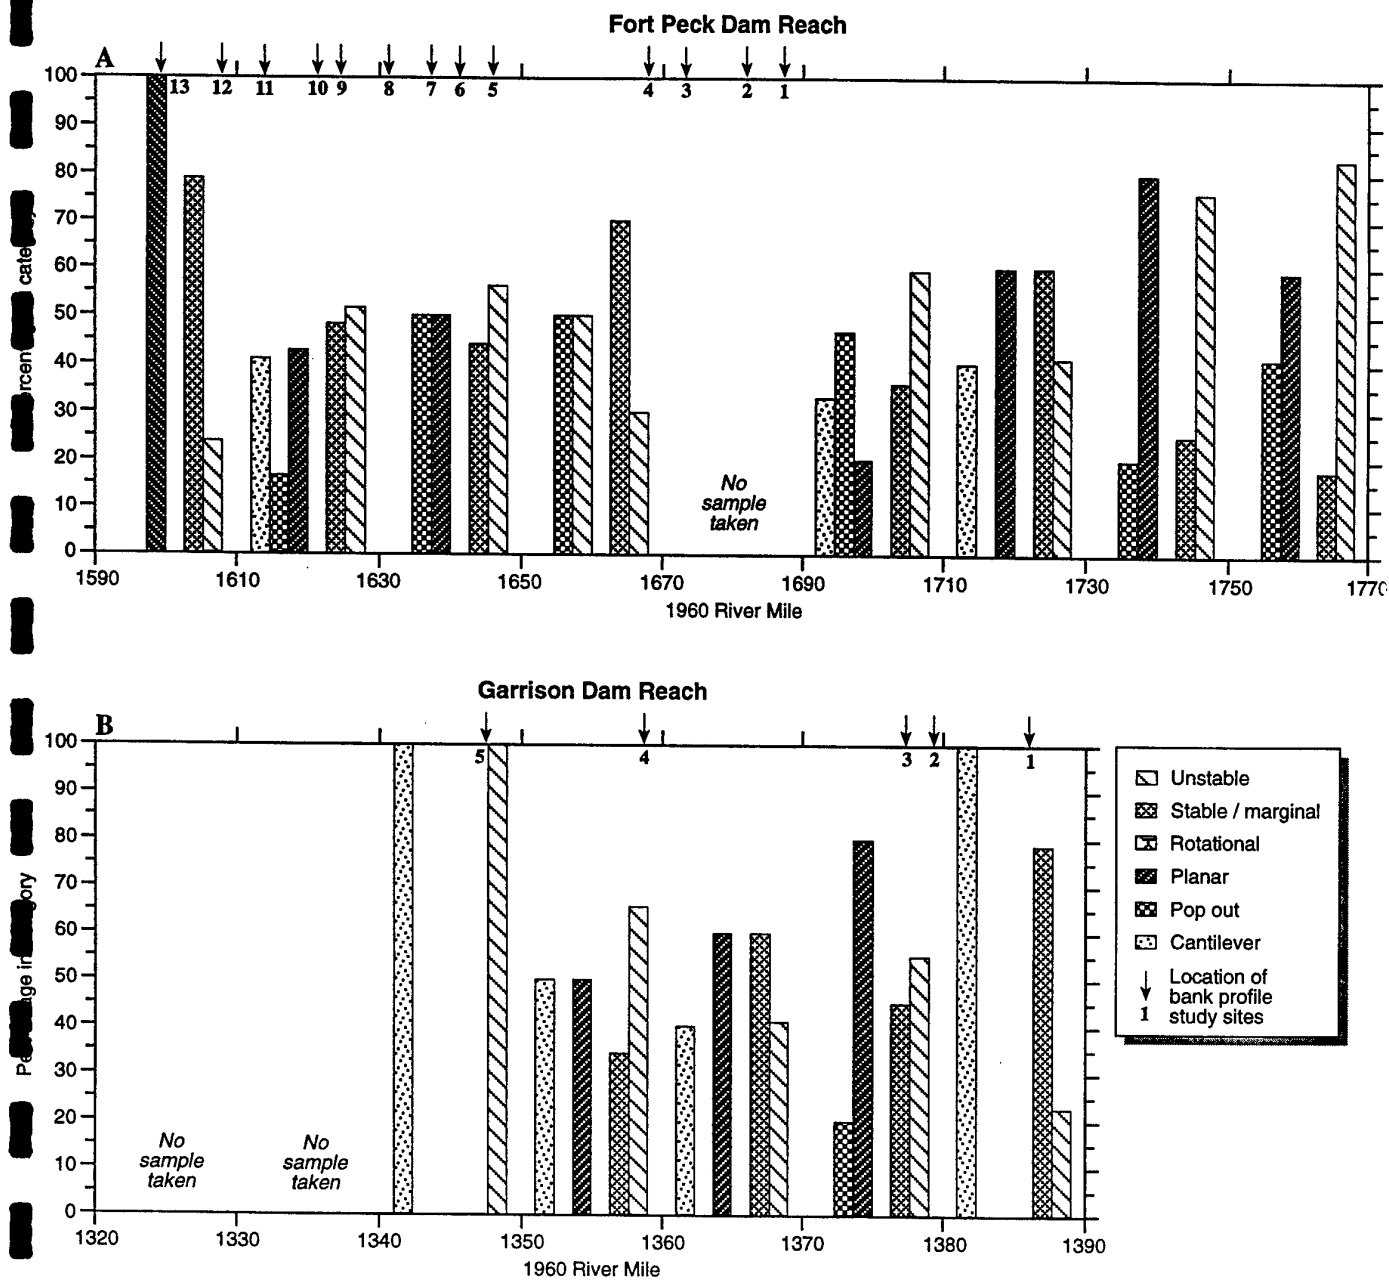
FIGURE 9

Figure 9a shows a general tendency for the severity of bank instability observed during September 1995 to increase with distance downstream of Fort Peck dam. In contrast, bank instability decreases with distance downstream of Garrison dam (Figure 9b). Figure 9 shows

that the only systematic change in failure mechanism versus distance downstream is a relative increase in the frequency of cantilever failures in the Fort Peck dam reach (Figure 9a). Planar failures are the most common mechanism of bank collapse in this reach (with the exception of sub-reaches between RM 1750-1730 and RM 1710-1690). Planar failures are dominant in three of five sampled sub-reaches of the Garrison dam reach, although classifications are based on a relatively small sample size in the other two sub-reaches.

Figure 9. Classification of observed contemporary (1995) bankline stability conditions by location along: (A) Fort Peck dam study reach; (B) Garrison dam study reach. "No sample taken" indicates reaches where no field reconnaissance was made

Contemporary conditions of bankline stability are summarized in Figure 9 and Table 8. 57% of the banks reconnoitered in the Fort Peck dam reach display evidence of instability with respect to mass instability, compared to 41% in the Garrison dam reach. Planar failures are the most common mode of collapse, accounting for 45% and 59% of unstable banks in the Fort Peck and Garrison dam reaches, respectively. Popout (33% Fort Peck dam reach, 14% Garrison dam reach) and cantilever-type (19% Fort Peck dam reach, 27% Garrison dam reach) failures are also observed along shorter, but still significant, lengths of unstable bankline in both reaches.
